Thermal Control Replacement Materials Evaluated for Durability and Selected for the Hubble Space Telescope

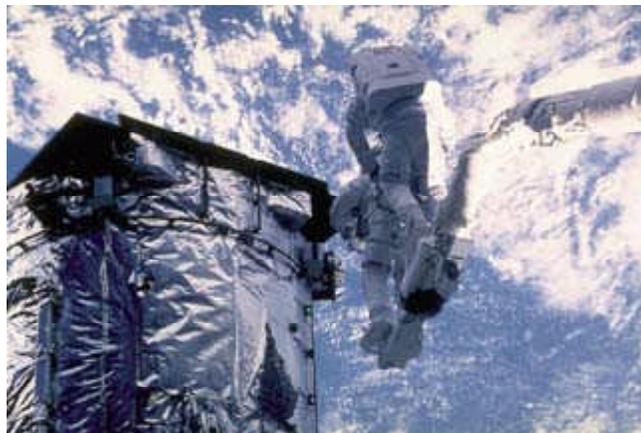
Photograph of Hubble Space telescope taken during the second servicing mission, showing the very large, vertical light shield cracked area and the tightly curled upper light shield cracked area.

The tightly curled, cracked FEP/VDA on the upper light shield was retrieved by astronauts and found to be severely embrittled, as witnessed by ground testing. The NASA Goddard Space Flight Center organized a Hubble Space Telescope MLI Failure Review Board, which included three members from Lewis, to (1) determine the damage mechanism of the (FEP/VDA) in the telescope's orbit environment, (2) predict the condition of the MLI at the time of the next servicing mission, and (3) recommend a replacement thermal control outer layer material to be installed on the telescope during

subsequent servicing missions. The Failure Review Board chose candidate thermal control replacement materials by using a multiplicative process recommended by the NASA Lewis Research Center. Ten candidate materials were tested for environmental durability under various exposures and durations as overseen by Goddard and Lewis. Lewis conducted x-ray radiation exposure, thermal cycling under load, and large-sample thermal cycling of candidate materials. Lewis' durability testing of candidate replacement materials and involvement on the Failure Review Board had a direct impact on the choice of the replacement thermal control material to be placed on the Hubble Space Telescope during subsequent servicing missions in 2000 and 2003. The recommended replacement thermal control material chosen by the review board and adopted by the Hubble Space Telescope project office is 5-mil FEP/VDA bonded with a low-outgassing ultraviolet-durable adhesive to a Nomex (DuPont) scrim.
